**SOUHEGAN RIVER WATERSHED
DAM NO. 28**

**NH 00429
NHWRB 147.26**

**PHASE I INSPECTION REPORT
NATIONAL DAM INSPECTION PROGRAM**

AUGUST 1979

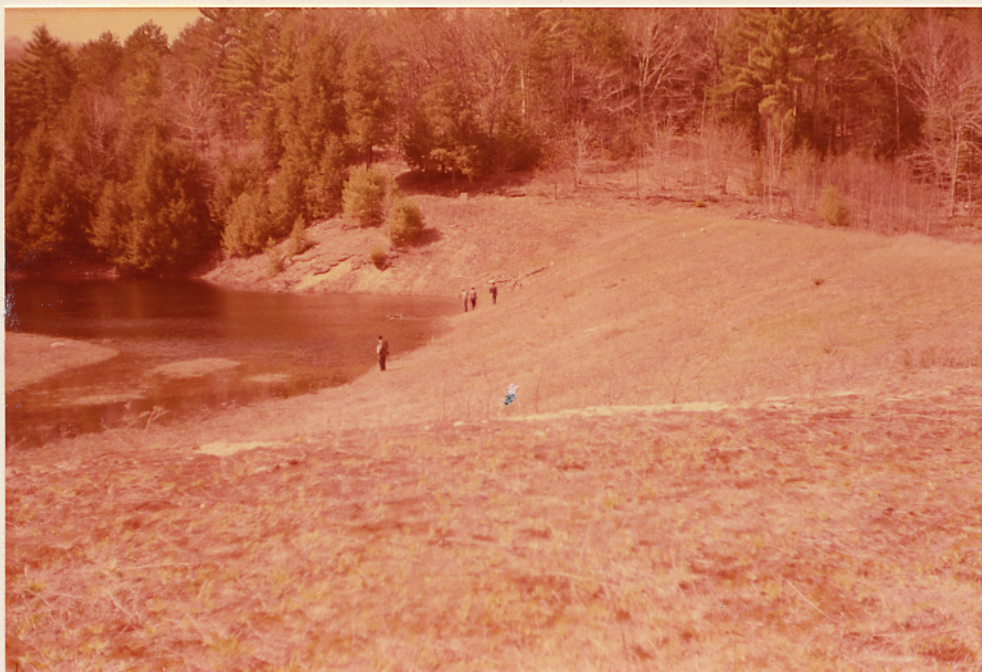
Overview of upstream slope

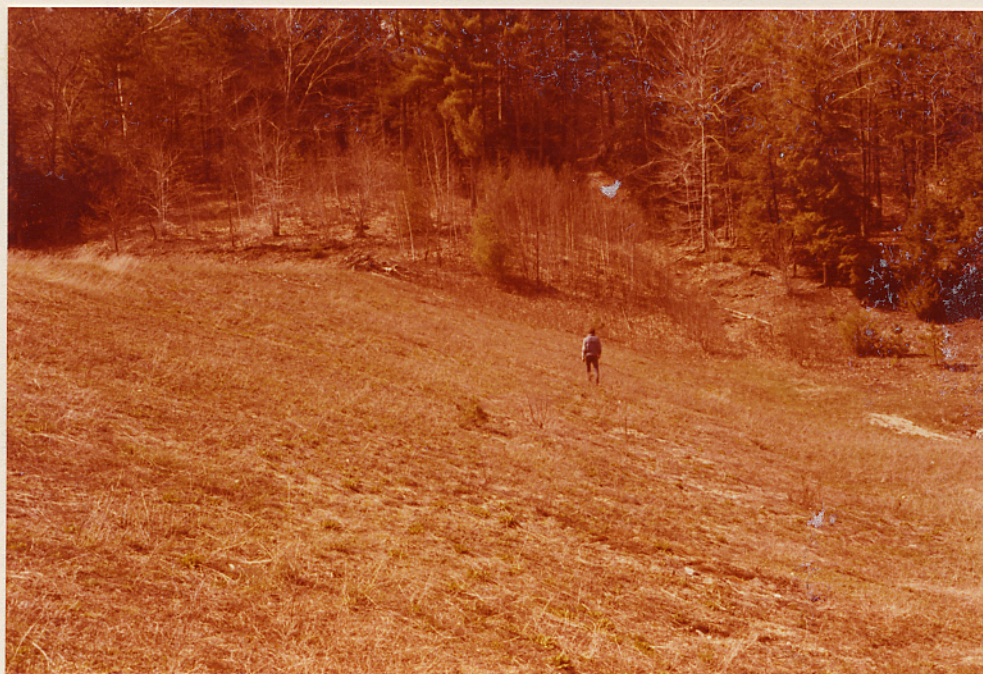
Overview of downstream slope

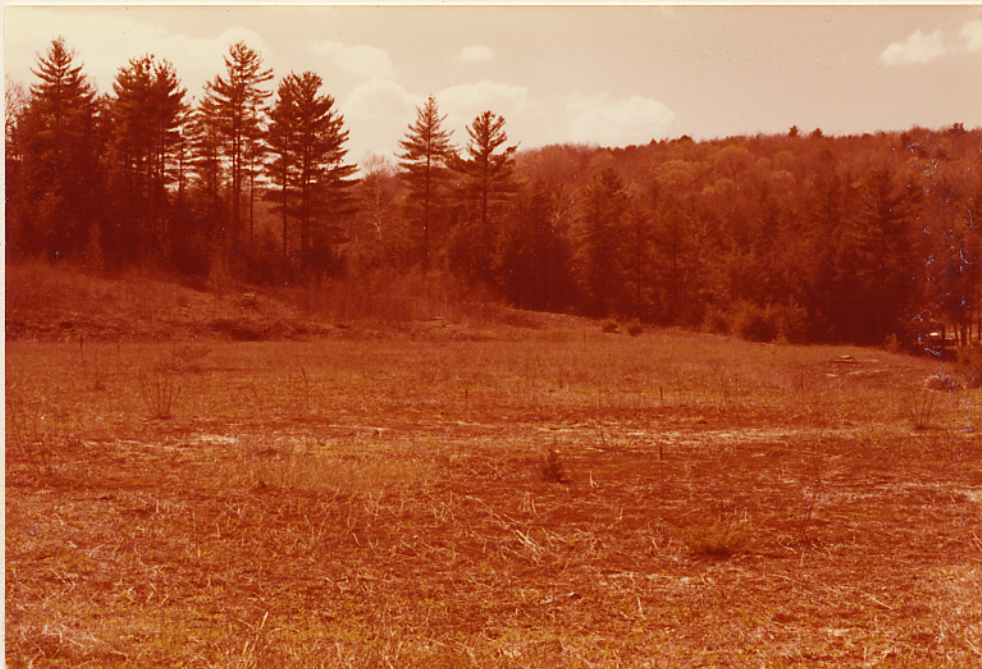
1. View of emergency spillway channel
looking upstream

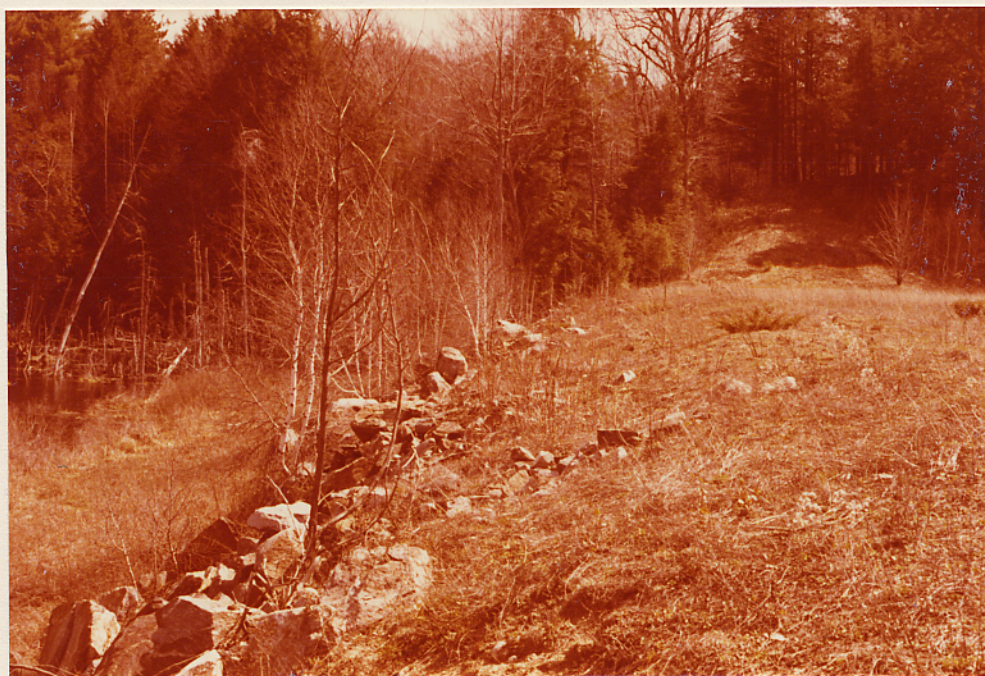
The emergency spillway is in good condition. There is some tree growth at the downstream end of the spillway.

2. View of downstream end of emergency
spillway showing rock dump fill and
tree growth

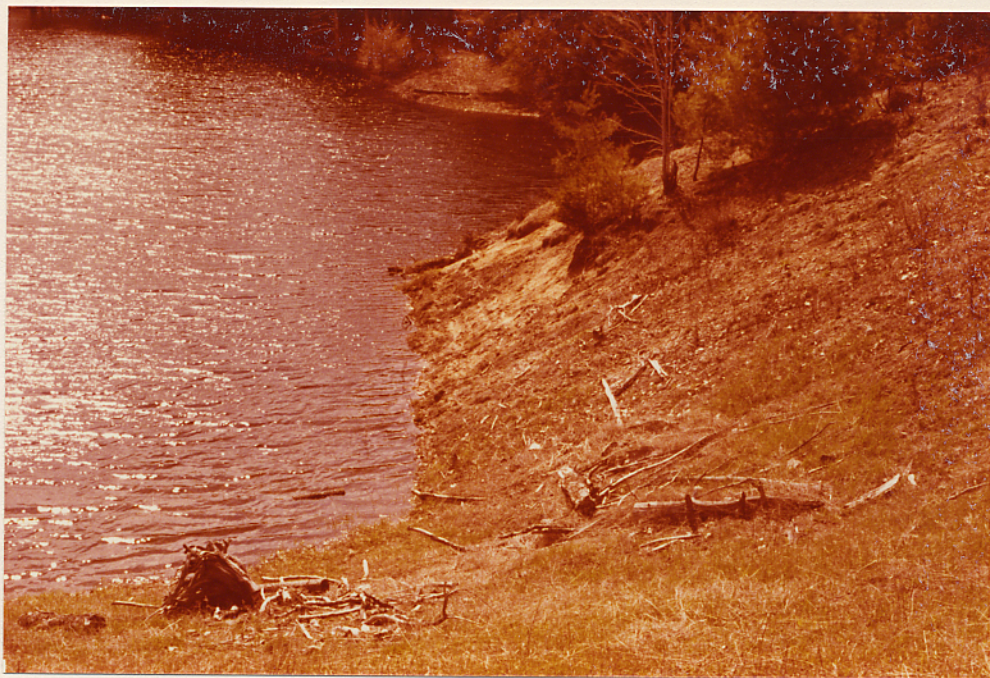
The shore of the reservoir is generally steep sloping woodland. It appears stable and in good condition except for a section approximately 100 feet long and 30 feet wide near the left abutment. This section shows recent, very shallow, sloughing of the grass cover. This sloughing is probably due to recent drawdown of the reservoir level after flooding.

3. View of left upstream reservoir slope showing debris and recent sloughing

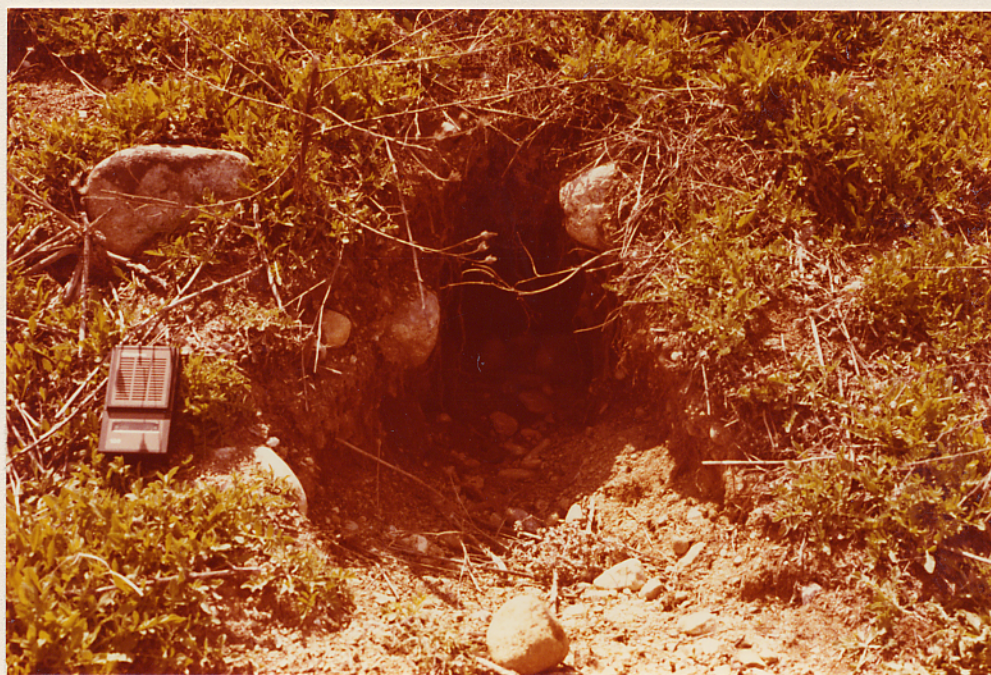
The earth embankment is generally in good condition. There are three small animal burrows in the downstream slope between the embankment and the emergency spillway. Photo No. 4 is a view of one of these holes. There are tire tracks near the downstream toe of the embankment and some debris on the upstream slope.

4. View of animal burrow in right downstream slope near the end of the embankment

The dam is in GOOD condition at the present time. Remedial measures to be undertaken by the owner include filling in animal burrows, mowing of slopes, including annual operation of drain gate in the inspection procedure, and developing a

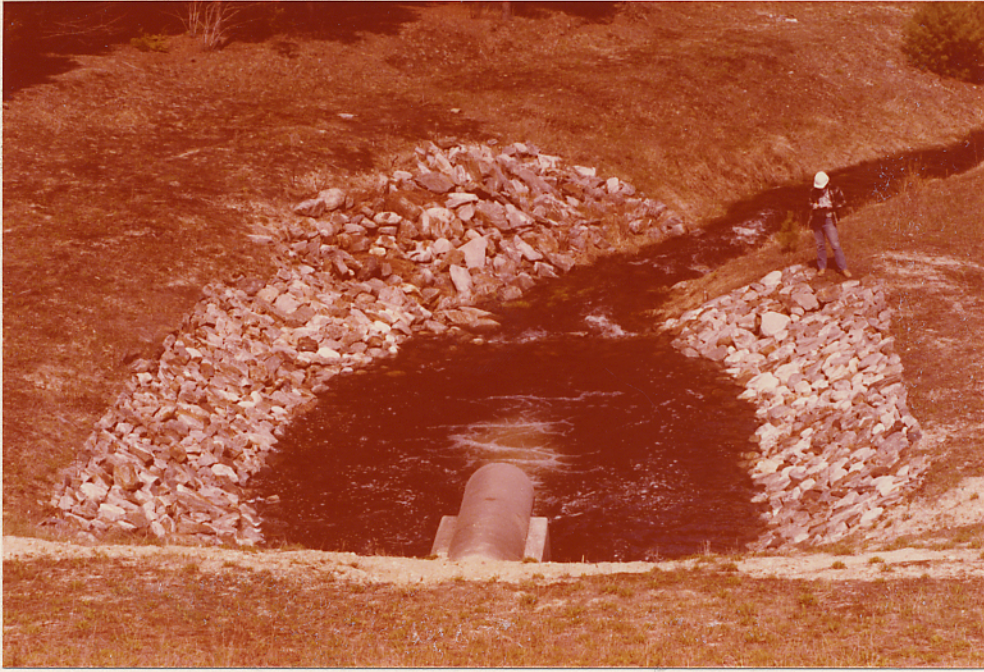
The plunge pool is protected by hand placed rip rap and is stable and in good condition.

5. View of downstream channel showing plunge pool and riprap protection

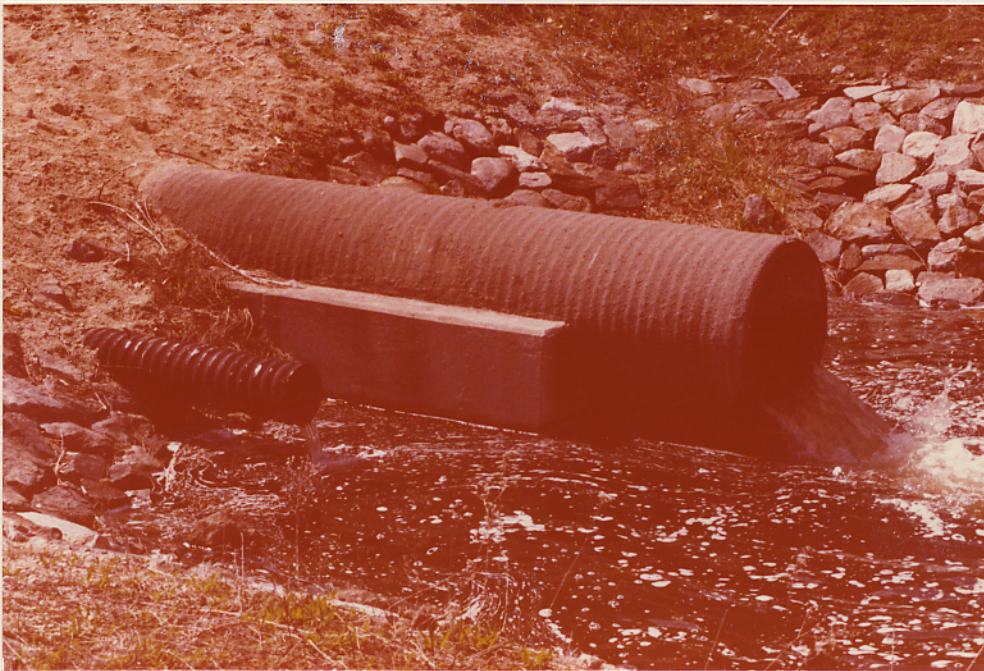
The downstream end of this conduit is in good condition with no evidence of settlement, spalls, cracks, or efflorescence. The supporting cradle is in good condition with the exception of minor spalling (8 square inches) at the downstream end.

6. View of outlet pipe and right toe drain outlet

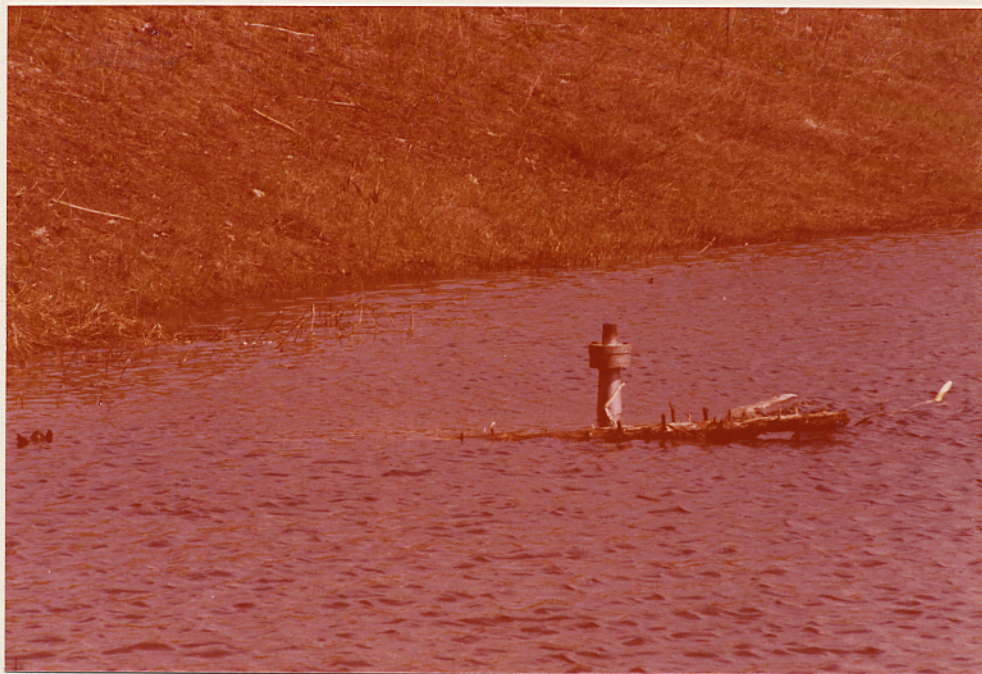
This structure was completely submerged at the time of inspection. The bench stand and vent pipe appear to be in good condition. Some debris was observed in the trash racks.

7. View of bench stand on submerged inlet structure
